Contract #: 04-0120F4Cty: SF/ALA Rte: 80 PM: 13.2/13.9File #: 82.28**WELDING INSPECTION REPORT****Resident Engineer:**Siegenthaler, Peter**Address:** 333 Burma Road**City:** Oakland, CA 94607**Report No:** WIR-026219**Date Inspected:** 24-Aug-2011**Project Name:** SAS Superstructure**OSM Arrival Time:** 630**Prime Contractor:** American Bridge/Fluor Enterprises, a JV**OSM Departure Time:** 1500**Contractor:** Westmont Industries**Location:** Santa Fe Springs, CA**CWI Name:** Ruben Dominguez**CWI Present:** Yes No**Inspected CWI report:** Yes No N/A**Rod Oven in Use:** Yes No N/A**Electrode to specification:** Yes No N/A**Weld Procedures Followed:** Yes No N/A**Qualified Welders:** Yes No N/A**Verified Joint Fit-up:** Yes No N/A**Approved Drawings:** Yes No N/A**Approved WPS:** Yes No N/A**Delayed / Cancelled:** Yes No N/A**Bridge No:** 34-0006 L & R**Component:** Maintenance Travelers**Summary of Items Observed:**

WELDING INSPECTION REPORT

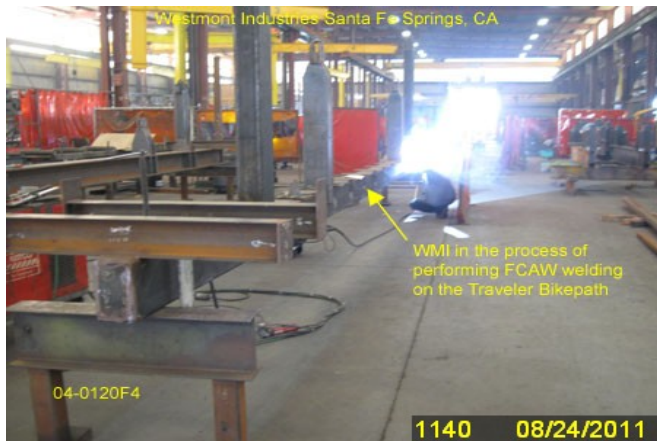
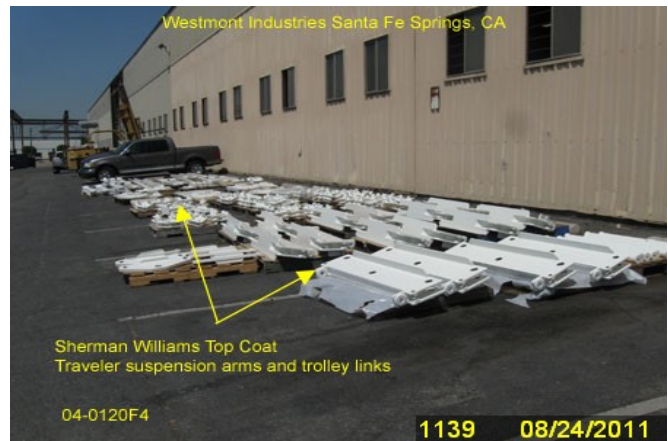
This QA Inspector observed that the activities mentioned above, appeared to be in compliance with the contract requirements and this QA Inspector observed no non-conforming issues, on this date.
